SAS Superstructure

Daily Diary Report by Bid Item

04-0120F4
04-SF-80-13.2/13.9
Self-Anchored
Suspension Bridge

Install & Adjust PWS 1-5

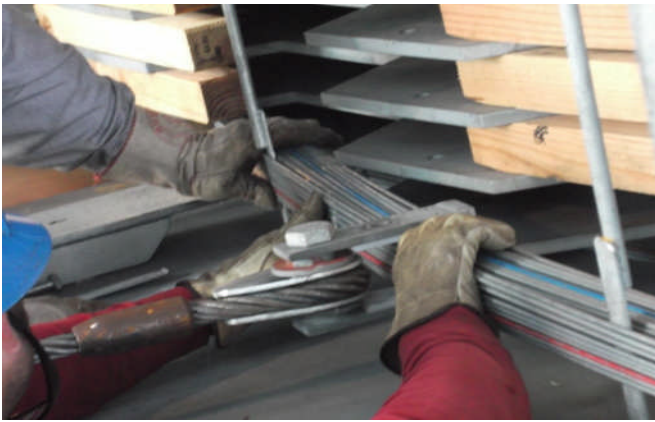
- At 13:50, the wire issues were resolved, and they started to re-install the strand (see attached photo).
- At 15:35, the installation was complete.

After photo - Wire configuration appeared OK when installation re-started

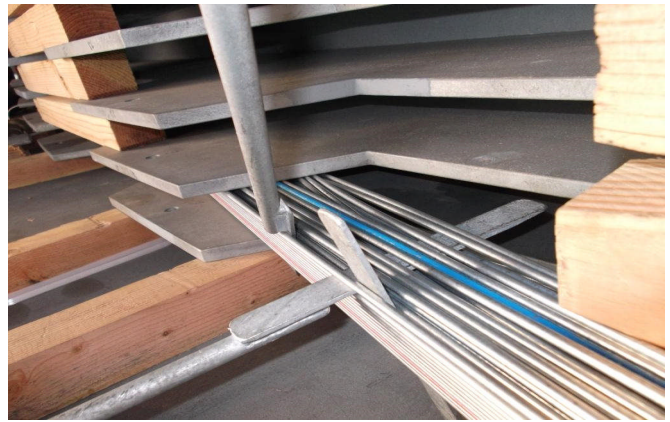
- When I arrived at the South W2 saddle, the installation was about 3/4th complete, but they had a couple of issues with the installation. Warren stayed for a while to make sure I was up to speed on the particulars. They had some issues with crossing wires in the last 2m of the installed strand. Also, there appeared to be crossing wires in the area where the strand was just entering the trough (see attached photo). Karsten and Adam Roebuck came to the site to try to help them correct the issue.

Before photo - Crossing wires in strand when entering trough (this was later removed)

- They worked until 13:35 trying to resolve the issue, and then ABF decided to remove the strand back to a point where the installed strand was good. They removed about 2.2m of installed strand.
